APPENDIX 9

PHASE 1B/2 CONSTRUCTION INSPECTION FORMS

Pine Street Canal Site,
1-0870-1 (541),
West Bank Capping:
Environmental Controls
Daily Inspection Checklist
11/24/03-

PINE STREET CANAL SITE – WEST BANK CAPPING
ENVIRONMENTAL CONTROLS DAILY INSPECTION CHECKLIST

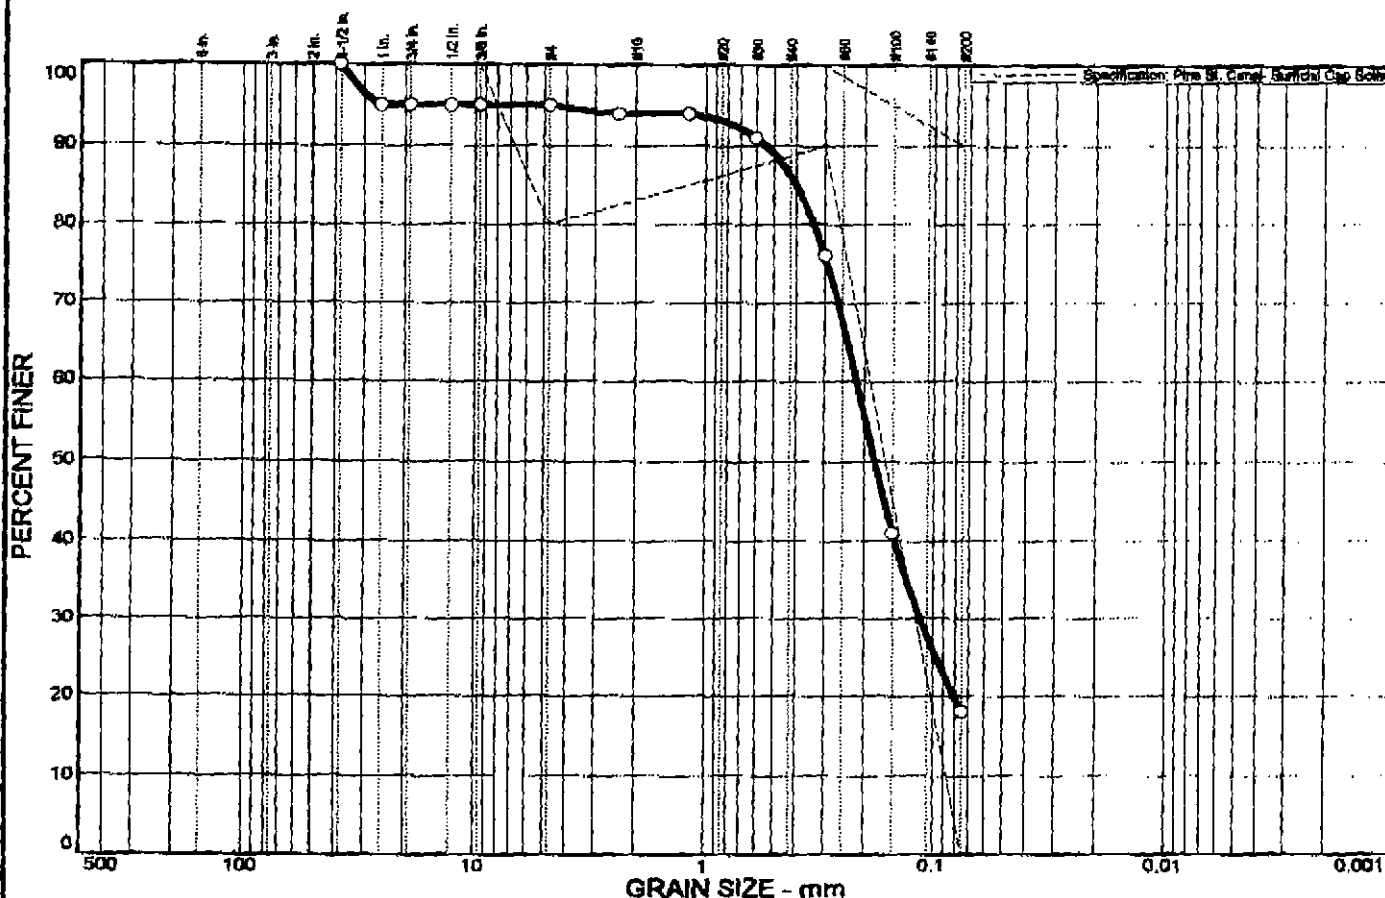
Grain Size Distribution Report

% COBBLES	% GRAVEL	% SAND	% SILT	% CLAY
0	5	77	18

SIEVE SIZE	PERCENT FINER	SPEC." PERCENT	PASS? (X=NO)
1-1/2 in.	100		
1 in.	95		
3/4 in.	95		
1/2 in.	95		
3/8 in.	95	100 - 100	X
#4	95	80 - 100	
#8	94		
#16	94		
#30	91		
#50	76	90 - 100	X
#100	41		
#200	18	0 - 90
